Preventing Buffalo River Bank Erosion with the help of Remote Sensing

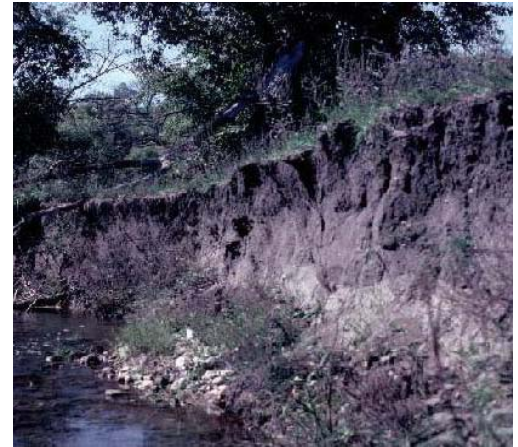
Figure 1. An example of river bank erosion in a Minnesota stream.

River bank erosion (see Figure 1) contributes to large amounts of sedimentation in rivers, lakes and reservoirs. Besides loss of land, river bank erosion results in poor water quality. Noreen Thomas lives on the banks of the Buffalo River outside Moorhead, Minnesota and took action when she noticed the bank of the river caving in and moving closer to her home and farm.

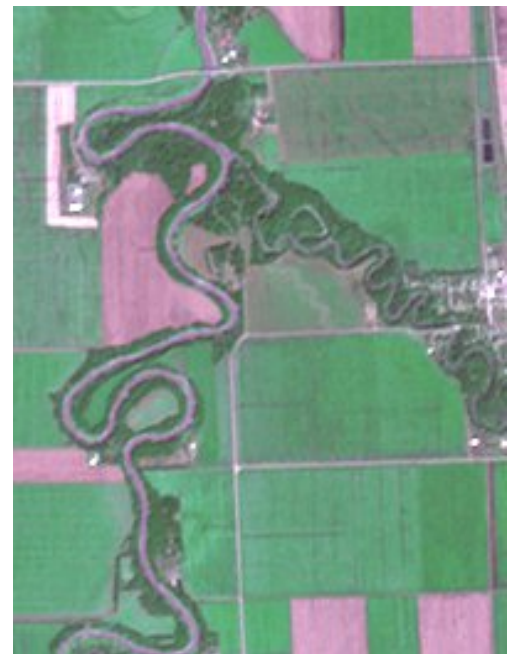
Figure 2. The confluence of the Buffalo and Red Rivers just north of Fargo, ND. Like the section of the river near the Thomas farm, the banks of this stream are well buffered from erosion by lush plantings which are evident in this ASTER satellite image from September 2003. (Image displayed in pseudo natural color, band combination red (R), infrared (IR), green (G)).

Using current and historical images of the Buffalo River (Figure 2), Noreen convinced her county water board to reject draining more water into the river. Images dating back to the 1970s showed the river's severe meandering and how much land it had claimed in almost thirty years. She then used the images to find places along the river where erosion was the worst. Noreen's family then teamed with local Boy Scout troops to plant low growing bushes, trees and native grasses. The roots of these plants help to hold the soil in place. Within only a few months, the new plants grew roots and held the soil against the raging river.
